# ***Bike / Pedestrian Improvements***

## ***Waterville Valley, New Hampshire***

# Bike and Pedestrian Accommodations

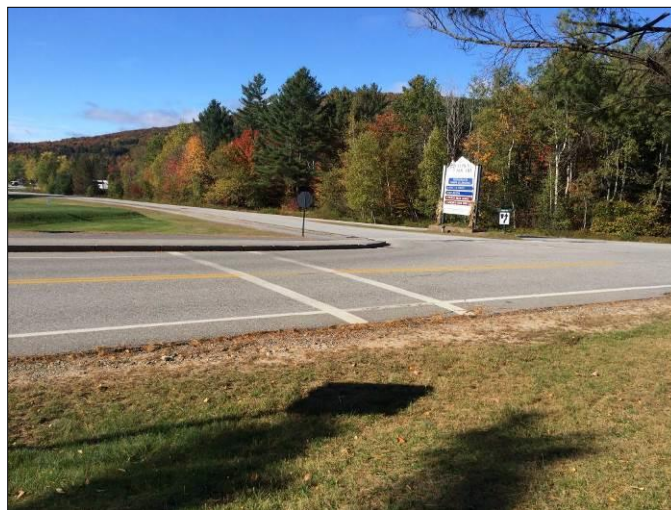
Few if any of the existing pedestrian crossings have Americans with Disabilities Act (ADA) compliant pedestrian ramps. Deficiencies include excessive longitudinal or cross slopes on the ramps, lack of visual contrast between the ramps, the sidewalk and the road, and lack of Detectable Warning Surfaces (DWS) in the pedestrian ramps. There are even locations where there are crosswalks but no sidewalks or pedestrian ramps to receive pedestrians, and in at least one crosswalk location there is no break in the full height vertical granite curb, making that crossing completely inaccessible to people in wheelchairs.

Make all pedestrian ramps Americans with Disabilities Act (ADA) compliant. This means improving the geometry and materials at the deficient ramps. It also means installing Detectable Warning Surfaces (DWS) in the pedestrian ramps for the benefit of vision impaired pedestrians. This includes locations where multi-use paths cross roadways.

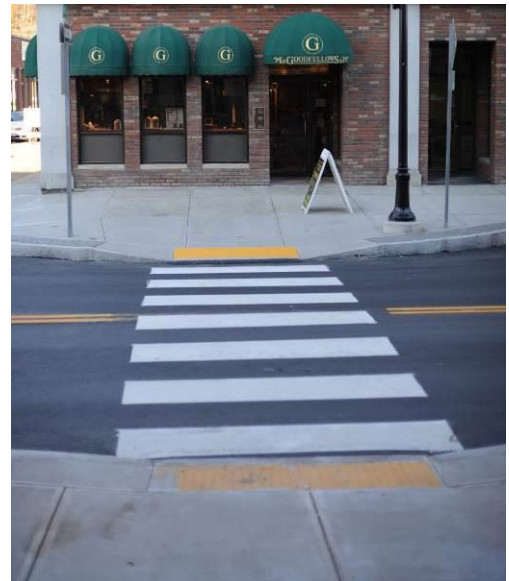
Consider Town-wide adoption of the ladder style reflectorized crosswalk pavement markings for new and rejuvenated crosswalks.

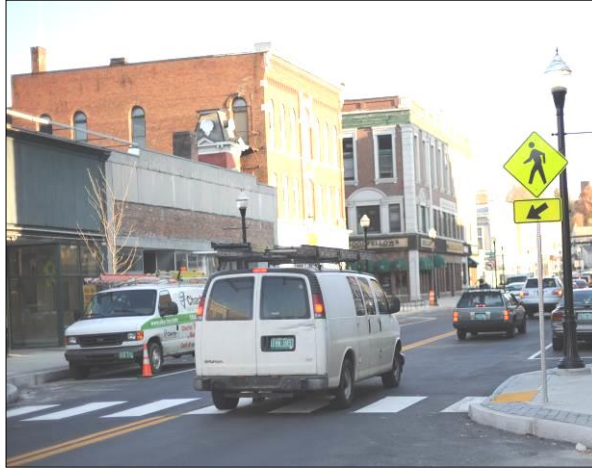
Typical pedestrian crossing signs at a mid-block crosswalk.

Note the street light near the crosswalk and the ladder style crosswalk markings.

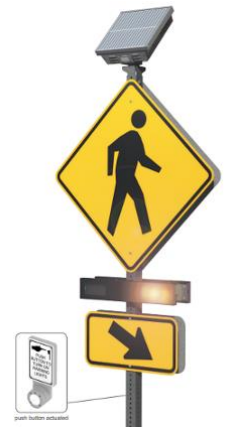
3. The third level of improvement would be provided by Rectangular Rapid Flashing Beacons (RRFB's) attached to crossing signs. RRFB's consist of pedestrian actuated flashing strobe lights attached to the crossing signs located on both sides of the crossing. These are intended to catch the attention of motorists when there are pedestrians crossing or waiting to cross. They do not stop traffic like the above two options so pedestrians must still judge when it is safe to cross. RRFB's are appropriate on roadways with speeds under 40 MPH, and there are no pedestrian volume warrants to be met. RRFB's are relatively low cost and can be solar powered.

Our recommendation is to consider RRFB's at pedestrian crossings on primary roads and where there is known pedestrian activity. We advise against overuse of RRFB's throughout the Town since it can dilute their effectiveness. Likely candidate locations for RRFB's are crosswalks on Valley Road at Tecumseh, Packard's, Village and Boulder Path Roads. The mid-block crossings on Boulder Path Road may also be appropriate locations for RRFB's. An added side benefit to adding RRFB's on Valley Road is that they will provide yet another visual key that pedestrian accommodations are important in Town.

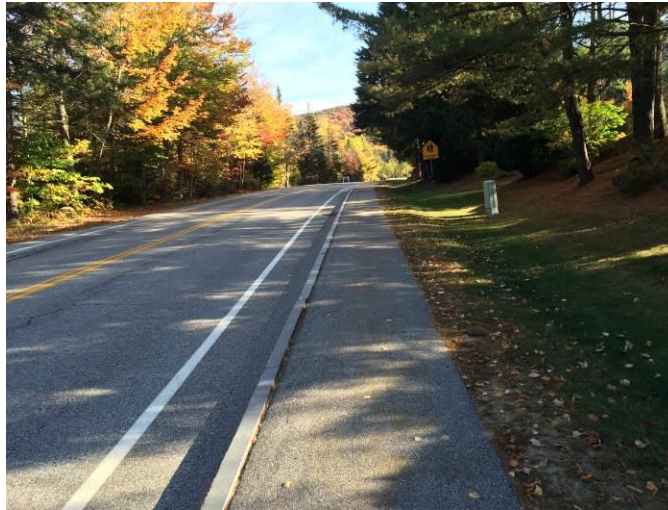
Left:  
5' wide sidewalk along the east side of Valley Road in the vicinity of Tecumseh Road

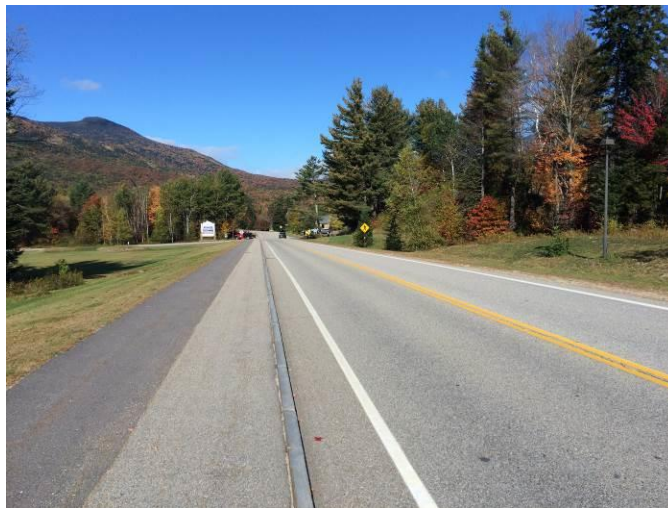
Left:  
10' wide sidewalk along the west side of Valley Road in the vicinity of the approach to Village Road (note that dark pavement is where sidewalk was widened)

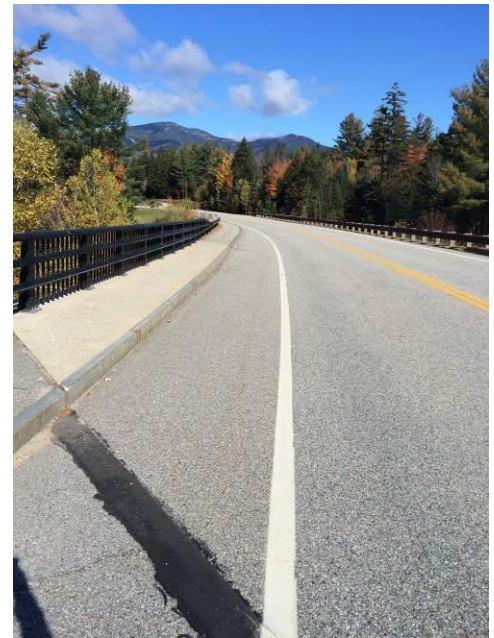
Below (Left & Right):  
5' wide sidewalks along the west side of Valley Road in the vicinity of the bridges over the ski trail (left) and Snows Brook (right)

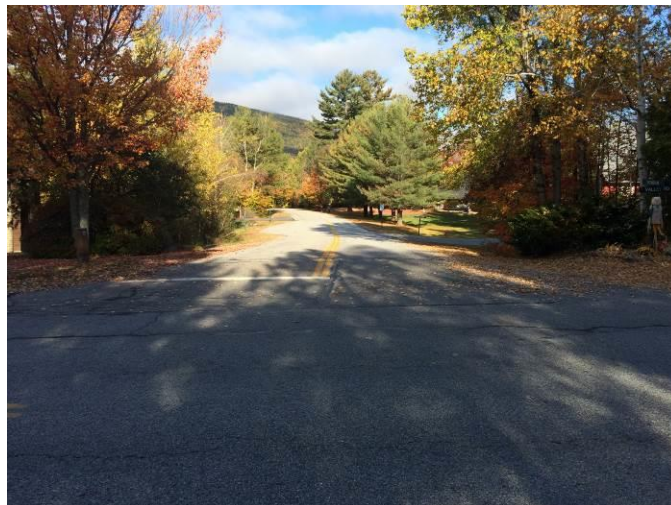
Left:  
Tecumseh Road as seen  
from Valley Road

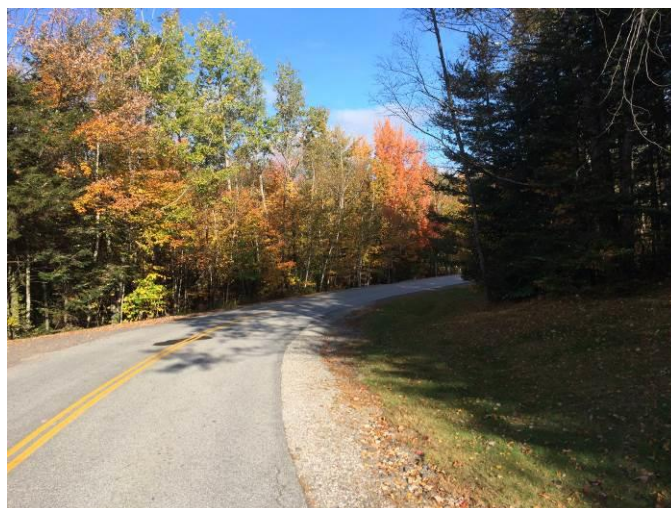
Left:  
Curved section of  
Tecumseh Road midway  
between Valley Road and  
Snows Brook Road

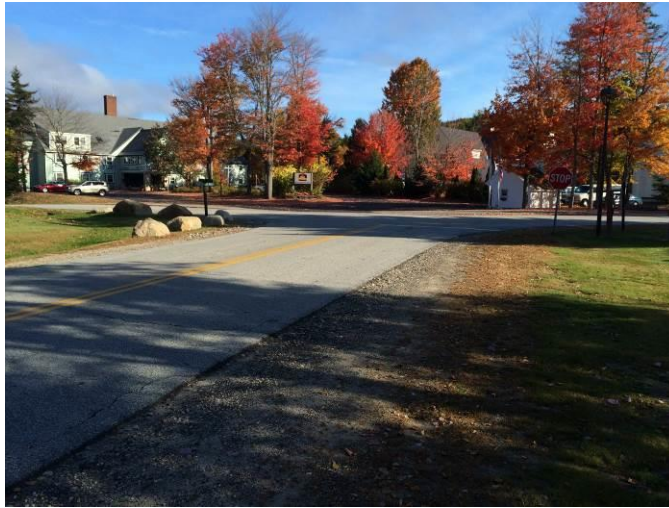
Left:  
Tecumseh Road approach  
to Snows Brook Road (left)  
and Packard's Road (right)

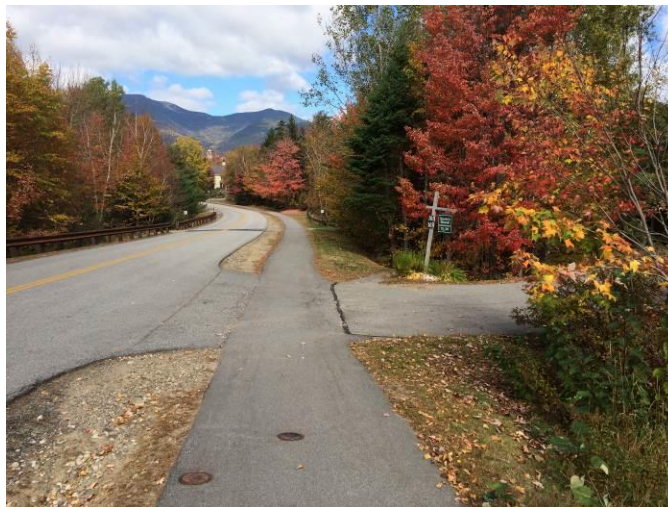
Left:  
Sidewalk along the east  
side of Snows Brook Road

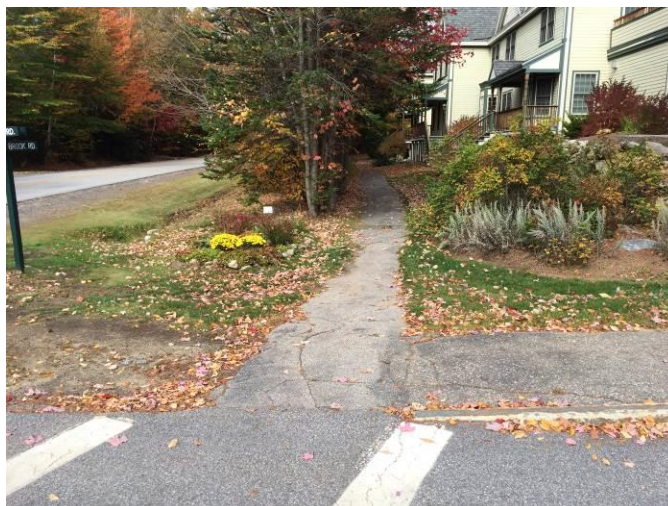
Left:  
4' wide sidewalk along the  
east side of Snows Brook  
Road; not Town  
maintained.

The existing 4 foot wide sidewalk that is not town maintained in the winter is the primary concern on this roadway since it represents a discontinuity in the winter and it is of substandard width in the summer. The fact that it is so close to the residential units leads us to believe it is not within a Town right-of-way. Widening the sidewalk to a 6 foot width closer to the road to make winter maintenance by the Town possible should be explored. Refer to Section #4 of the Streetscape Sections figure provided elsewhere in this document for a graphical representation of the improvements.

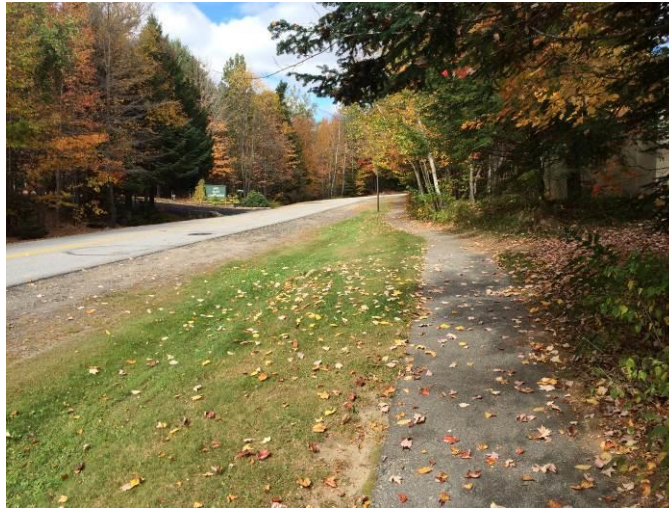
Left:  
4' wide sidewalk along the east side of Snows Brook Road; not Town maintained.

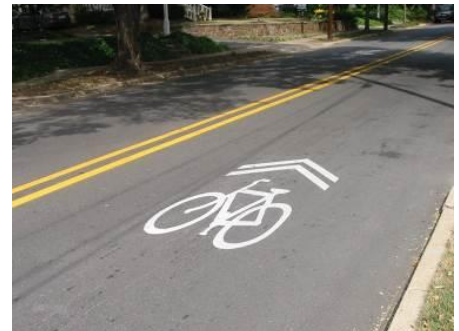
Similar to Tecumseh Road, we recommend shared use of the road by bikes. The enhancements would include shared lane arrows and "Share the Road" signs.

Also similar to Tecumseh Road, children and other inexperienced cyclists may still ride on the sidewalk. The Snows Brook Road may be a candidate for an 8 foot wide path if this is strong concern.

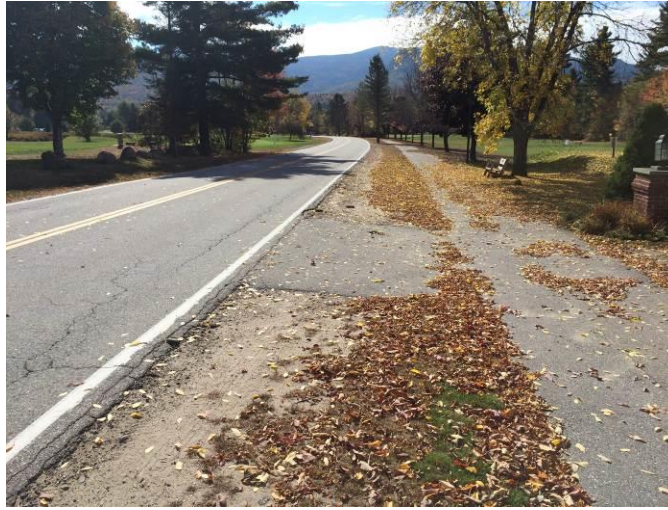
Left:  
8' wide path along Boulder Path Road and the golf course

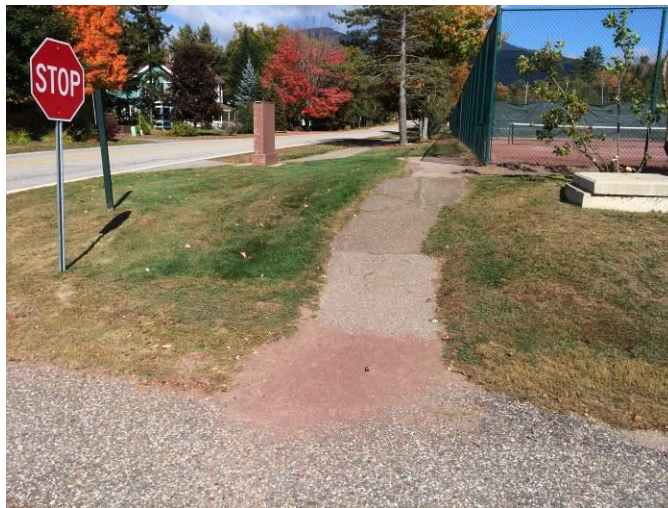
Left:  
4' wide sidewalk at the tennis courts. Note the lack of ADA compliant ramp and position behind the stop line.

Pedestrians are well accommodated along this roadway on the wide path segments. The only section of concern is the narrow section by the tennis courts. There are also ADA concerns in that area due to the steep sidewalk slope at the Snows Mountain Road intersection. We recommend reconstructing the sidewalk in the area of the tennis courts to match the width of the path by the golf course. In addition, the crosswalk across Snows Mountain Road should be realigned to cross in front of the stop line. The existing crossing is aligned behind the stop line, which is prohibited. The existing path has two mid-block crossings of Boulder Path Road. The northern crossing is skewed and we recommend reconfiguring it to a perpendicular crossing with the appropriate crossing signs.

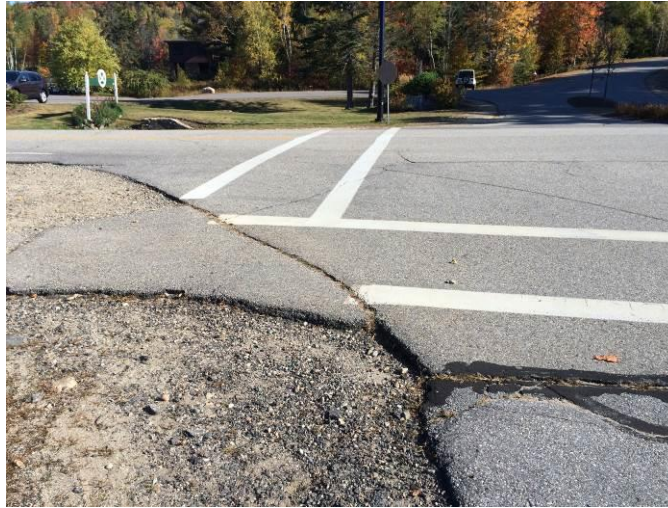
Left:  
Crosswalk across Valley Road from Village Road to vicinity of Golf Course with no connecting sidewalk. Also note typical lack of ADA compliant pedestrian ramps.

At the four-way intersection of Valley Road, Village Road and Lost Pass Road there are currently deficient pedestrian crossings accommodations. There are two crosswalks across Valley Road, one north and one south of the intersection. Neither of the crosswalks connect to sidewalks on the Lost Pass Road side of the intersection. We recommended that in the near term a short sidewalk be constructed from the northern crosswalk to the golf course parking lots since it is a likely destination and since pedestrians can access Lost Pass Road from there.

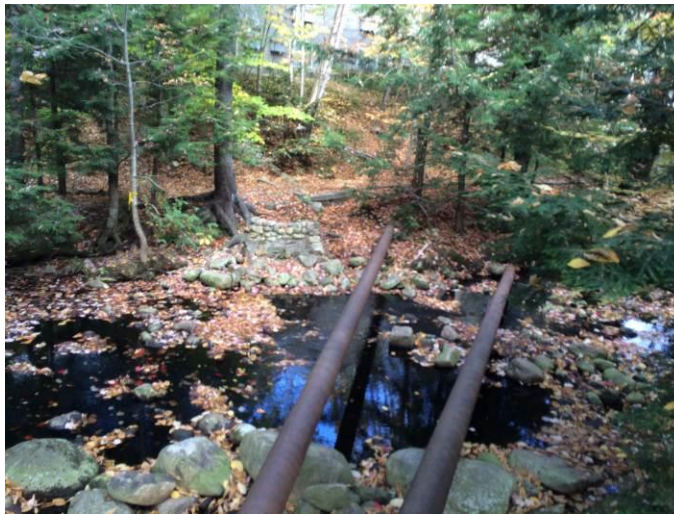
Left:  
The site of the Snows  
Brook bridge that was  
destroyed by flooding.

There is an opportunity to bridge the stream again at the former bridge location. That bridge would provide a north-south connection between the developments on the north side, including the Snowy Owl Inn, to the developments on the south side. The bridge would also complete an interesting short walking loop that would be available to a great number of visitors. In addition to a bridge, it may be possible to create a resting node at that location so visitors could stop and enjoy the river in a natural setting only a stone's throw from Town Square. The actual bridge could take many forms, including a prefabricated timber structure or potentially a suspension bridge.
